HO-98

McLaughlin-Campbell-Laumann Building
8060 Main Street, Ellicott City

Historic Properties Form

Inventory No. HO-98

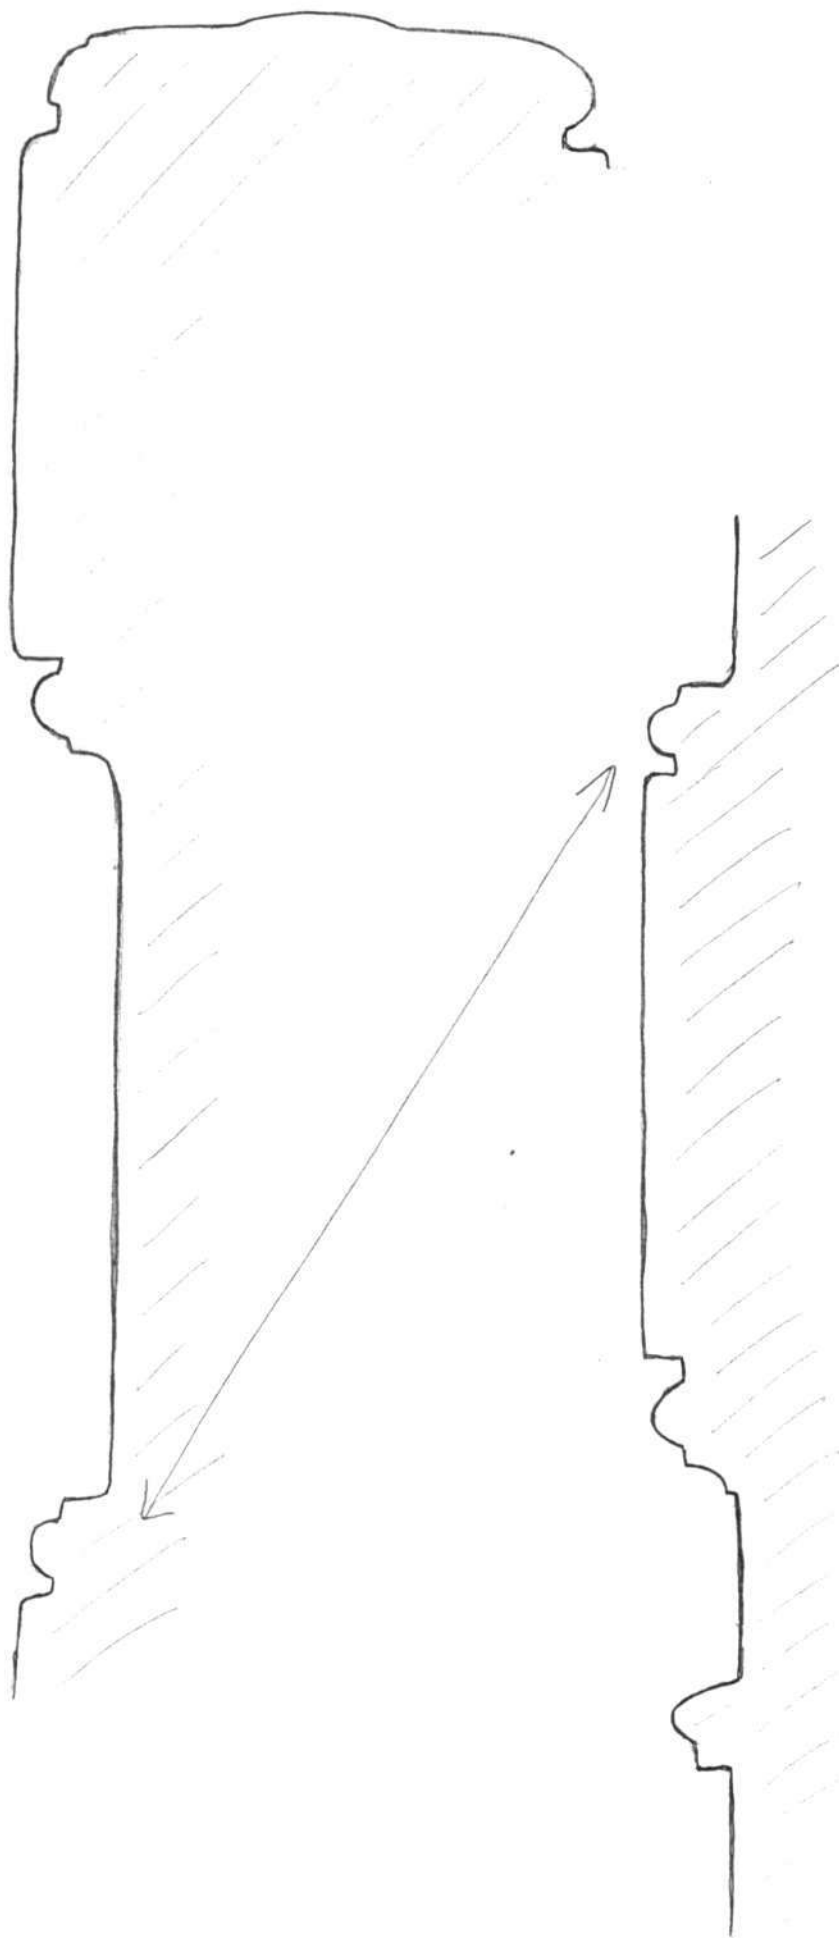
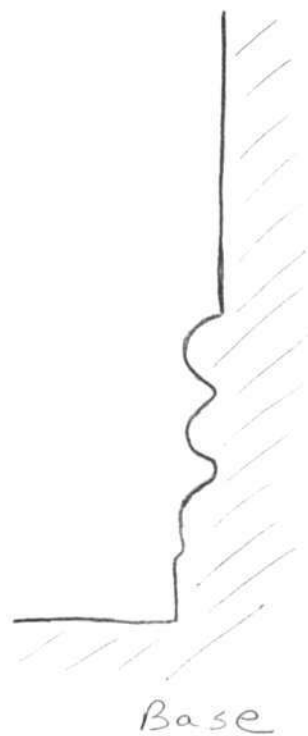
1/4 8060 Main St. - Ellicott City
Newel Post

The stairway landing has a doorway into the rear addition. The newel posts have a ghost of a three-quarter-round handrail. The second-story passage floor has rectangular-in-plan holes for balusters that are now missing and replaced with the existing balusters. The south half of the passage is closed off with a wall, and it is not possible to tell if this wall is original or added later. The stairs are now enclosed with drywall at the second story, with a doorway at the top of the stairs from the first story, but there were originally open railings. The passage flooring is random-width pine that runs east-west, and varies between 6 1/4 and 9 3/4 inches. This flooring runs throughout the second story. The east and west doors in the passage each have six panels with sunken fields and no panel moulds. The doors are mortised and tenoned and pinned and have architrave with two rabbets and plain corner blocks. Each has a four-light transom that is hinged at the top, and the transom bar also has two rabbets. The east door has cast iron butt hinges with three knuckles, and they appear to be plain. It has a later lock that is labeled "Norwalk L. Co." with a geometric band on it. The west door has a bronze Eastlake escutcheon and knob with no lock; this escutcheon has stylized foliage. The door is hung on new hinges. The second story center room partition wall is original, and the studs are lapped at the top and are cut back in order to nail them to the joist. The center chamber has new floorboards added on top of the old. The center posts in the south wall have down braces on the interior side, and they are only notched back about 1/2 to 3/4 of an inch and are toe-nailed. They go down toward the center of the building, not toward the east and west ends, and they have sawn marriage marks. The posts have hewn faces and sash-sawn sides. The attic story stair landing header is spiked to the joists like that on the second story.

The attic stairs continue up as below, and only the original newel posts survive. The landing has a three-over-three double hung sash set just above the baseboard, and the sash is 20th-century. The partition walls have now been opened up, and the doors have been removed. The rafters are exposed and have lath nail holes on them and on the collar beams. The rafters are 2 3/4 to 3 inches wide, and their depth is not determinable. The board collars are 1 by 6s that are nailed to the sides of the rafters with cut nails. The rafters are spaced 21 1/2 to 26 1/2 inches on centers. The flooring is pine that runs east-west and is 4 3/4 to 8 1/4 inches wide. It is face-nailed, and the nails have square heads. There are no fireplaces here on either end of the building. The rafter ridge has an open-faced bridle joint. What little dormer framing is visible suggests that they are original, and the dormers have triangular board collars that have lath nail holes on the bottom of them.

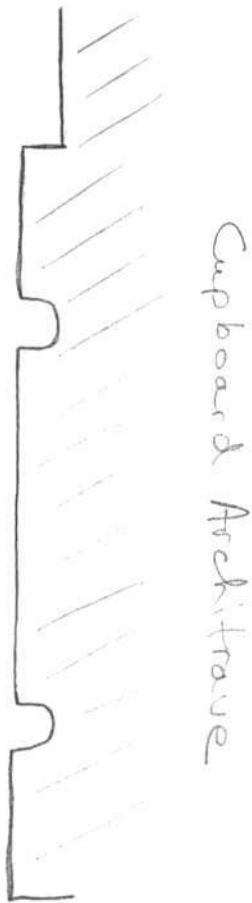
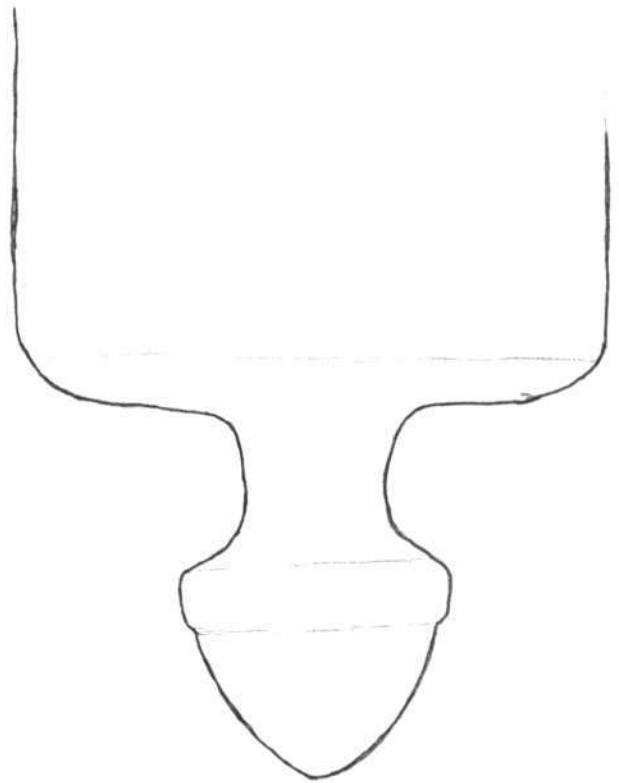
2/4 8060 Main St. - Ellicott City
Moulding Profiles

The back side of the cupboard has diagonal riven lath with plaster on the interior of the cupboard, and there is approximately 1 foot of space between the back of the cupboard and the west wall. The north side boards of the cupboard have cut nails coming through that must be original, and they have flat heads, not double-struck heads. At the north end of the east partition wall, under the stair landing, a stud is cut off where a door must have been cut through, since there is no header here. On the west wall, south of the fireplace, is a window opening framed into the wall, set close to the fireplace. The siding on the exterior beneath this window opening is sash-sawn, and the boards are flush on the interior. The exterior is not visible because a later stone building is built up against this wall. The interior of the window framing has plaster burns on it, and there is paint on the inner face of the opening. The west window outer frame has a bull nose, and the jambs have one rabbet for an outer stop, not a parting bead, as it is too close to the outer edge. There is evidence of two sash in the opening, with no gap between them on the jambs. The opening has board infill nailed with cut nails, with the stone wall of the adjoining structure behind this infill. There is a diagonal brace at the floor level, just south of the fireplace, which extends up behind the fireplace and must be the same brace visible behind the cupboard. This brace is on the interior face of the studs and had to be installed before the fireplace was erected.

Cupboard Architrave

Newel Pendant Drop

Cupboard Corner Block

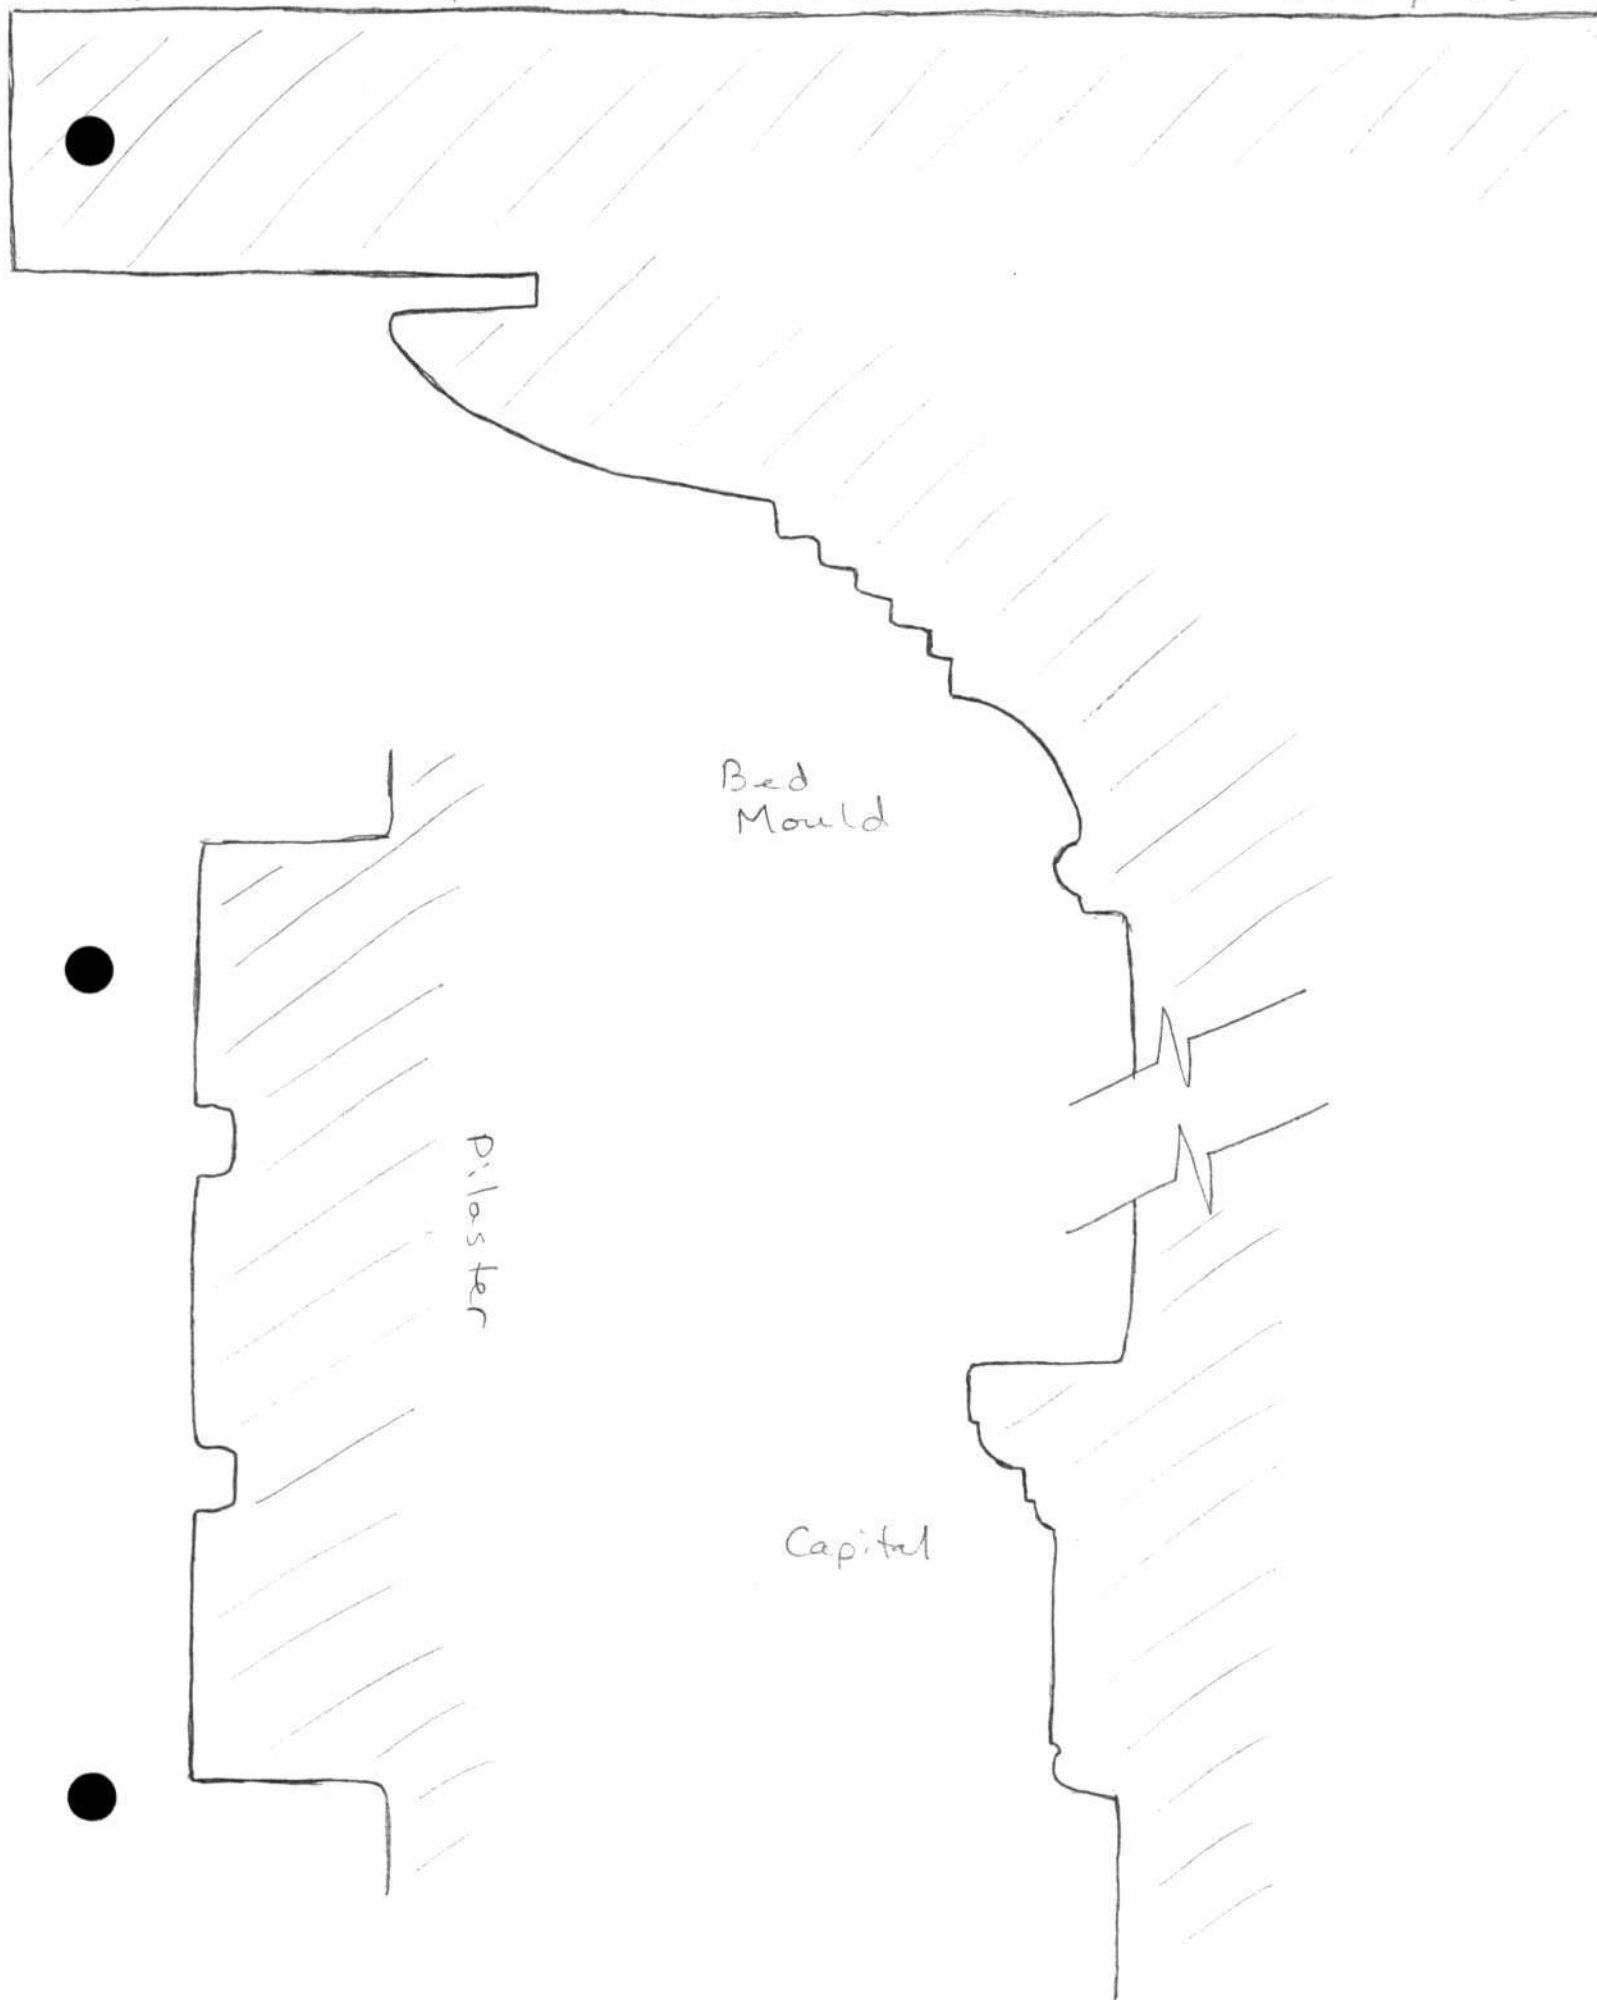
3/4 8060 Main St. - Ellicott City
First Story W. Rm. Mantel

The east room floor is covered with plywood. There is a fireplace centered on the east wall, with splayed brick jambs, original brick hearth, floor, and back wall to the firebox, and granite facings that

match those in the west room. There is a mantel that matches those in the west room though it is missing its capital moulding and some of its bed mould. The chimney brick is now exposed. To the south of the fireplace is a new door that leads to the exterior. The north wall has a new doorway with head-cut trim. The north side of this wall has German siding with a dark brown paint, and the siding is fastened with wire nails. Beneath the siding are earlier nail holes in the studs. The east corner post is sash-sawn, is at least 6 inches wide though it is not clear if the measurement can reach the corner of the post, and the post is 4 inches deep. It has a downbrace that is 1 1/4 by 7 inches, and is also sash-sawn. This brace is let into the corner post and the studs, and is fastened with cut nails. There is a 7-inch by 4-inch post east of the east partition wall of the passage. The flooring has a header near the north wall that cuts off three joists, and has a through-tenon with exposed wedge peg on each end. The joists have a center tenon into this header, and these tenons are not pegged but are cut flush with the north side of the header. This must have been an original stair opening. The header has three beveled notches at the top north corner, apparently for where studs were fastened for a wall that enclosed the stairway.

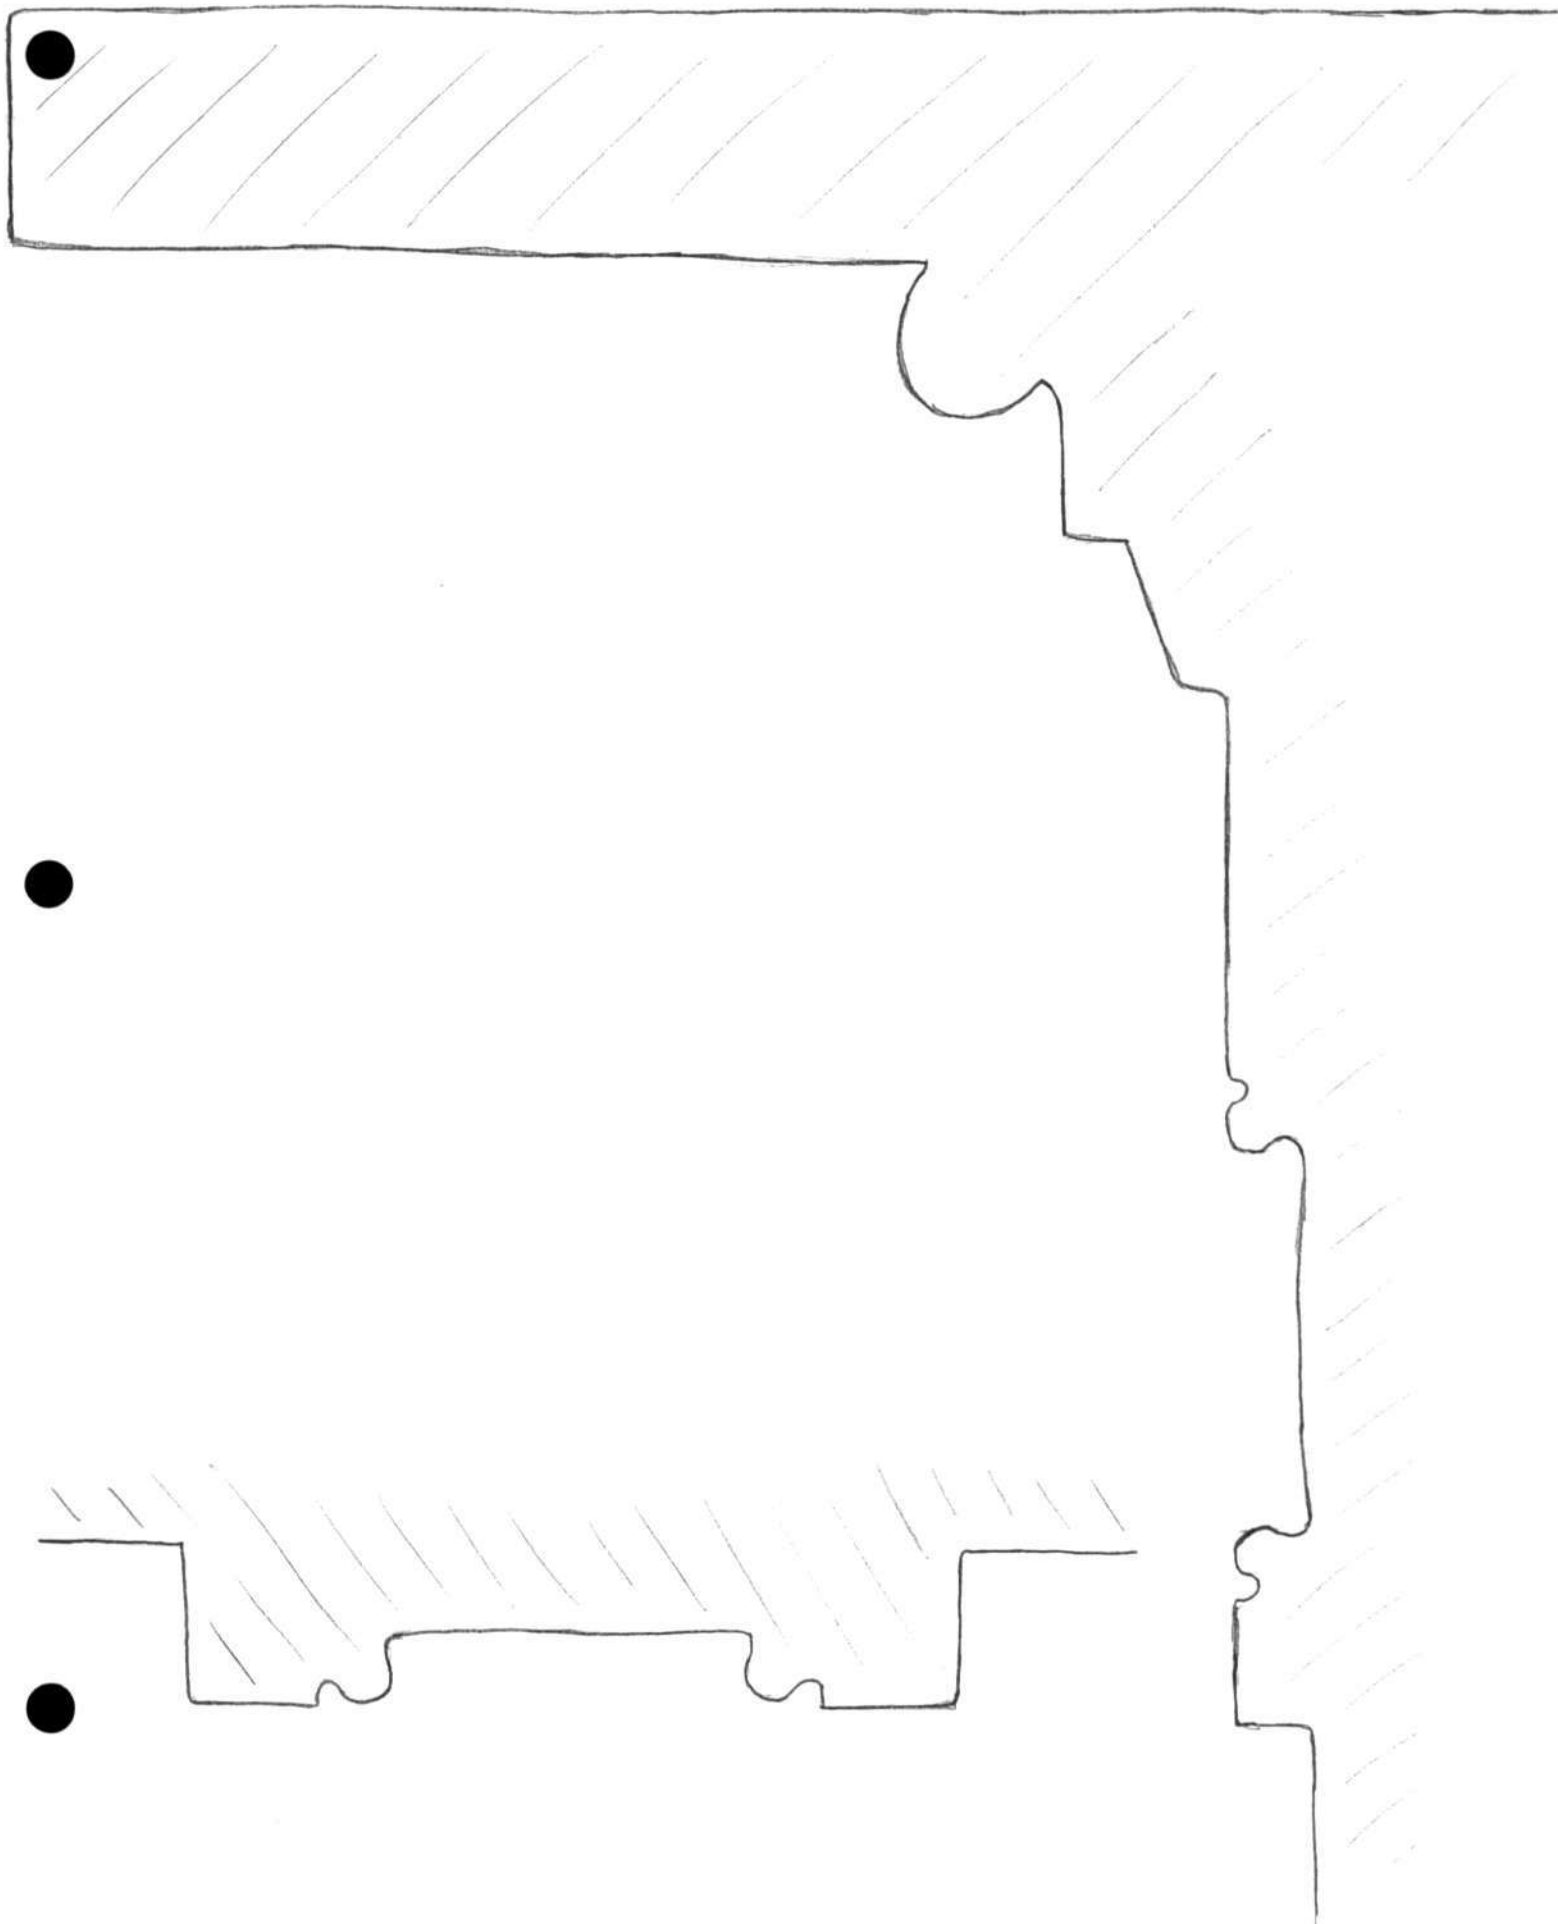
4/4 8060 Main St. - Ellicott City
Second Story E. Rm. Mantel

The east chamber has a fireplace centered on the east wall, with a new slate hearth, exposed brick, a rebuilt firebox, and it has a splayed brick jack arch. There is a wood mantel with paneled pilasters that are sunken and flat and have a bead panel mould. This treatment is also on the frieze, and there are corner blocks to match where the pilasters and frieze meet. The bed mould has a bead at the top, a fillet, and a bevel mould at the bottom. The shelf and bed mould break forward at the pilasters. This chamber has new baseboard, a new cupboard in the southwest corner, and a new window on the east elevation, south of the fireplace. There is some riven lath surviving on the north plate and behind the stairs. The studs are notched to take the landing joists.

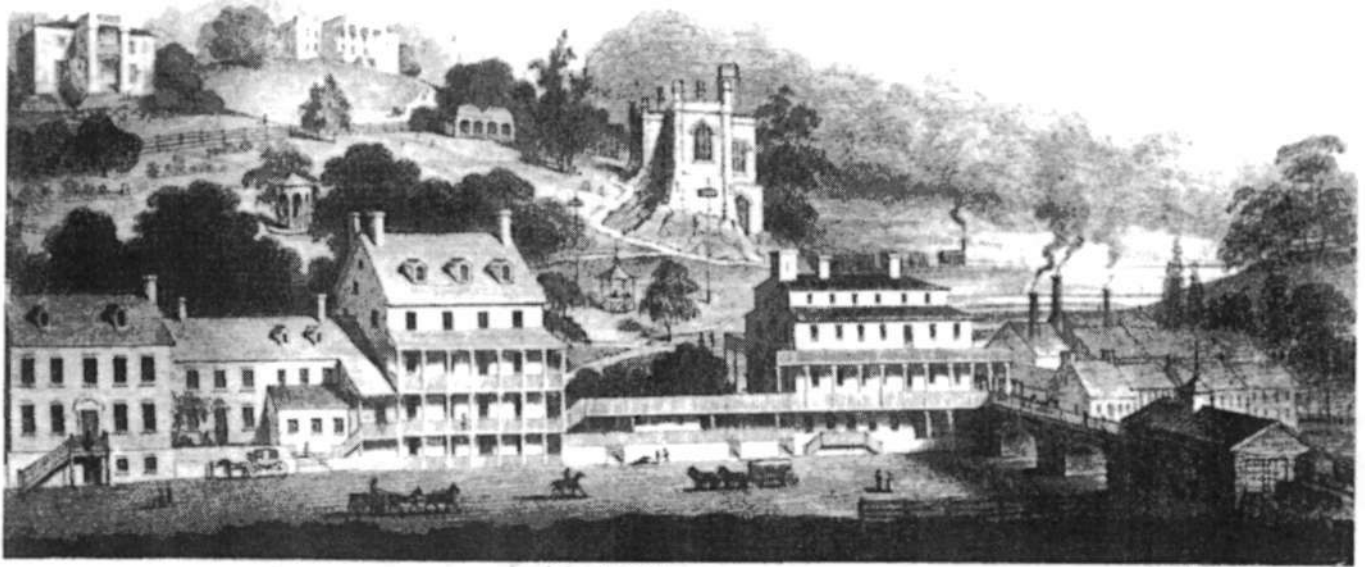
A SKETCH FROM ROCK HILL.

The advertisement included an engraving of the property, as seen from Rock Hill College, that was made by Baltimore architect Robert Carey Long, Jr. The most valuable prize was the hotel, which included a new addition alongside the railroad, a garden of almost three acres, a stone stable and carriage house, and an ice house, estimated to be worth \$36,500. Next came the property in question, "being a new three story dwelling with hewn granite basement, valued at 3,000." After that came Angelo Cottage, which was only valued at \$2,650. Though McLaughlin had it built as his home, he may have been living in the house on Main Street, which was probably started first, and he may never have finished the cottage; the cornerstone was only laid in June 1833, and work must have stopped by the time McLaughlin petitioned the Assembly. All of the other 20 lots were apparently unimproved, since they were merely described as building lots. The Main Street dwelling is shown on the left side of the engraving, much as it looks today except that there was a primary entrance in the center of the raised first story, with either a fan light or semi-circular pediment over the door and a porch and stairway leading up to it from the west.²

1833 Lottery ad, Hambleton Collection, Peale Museum

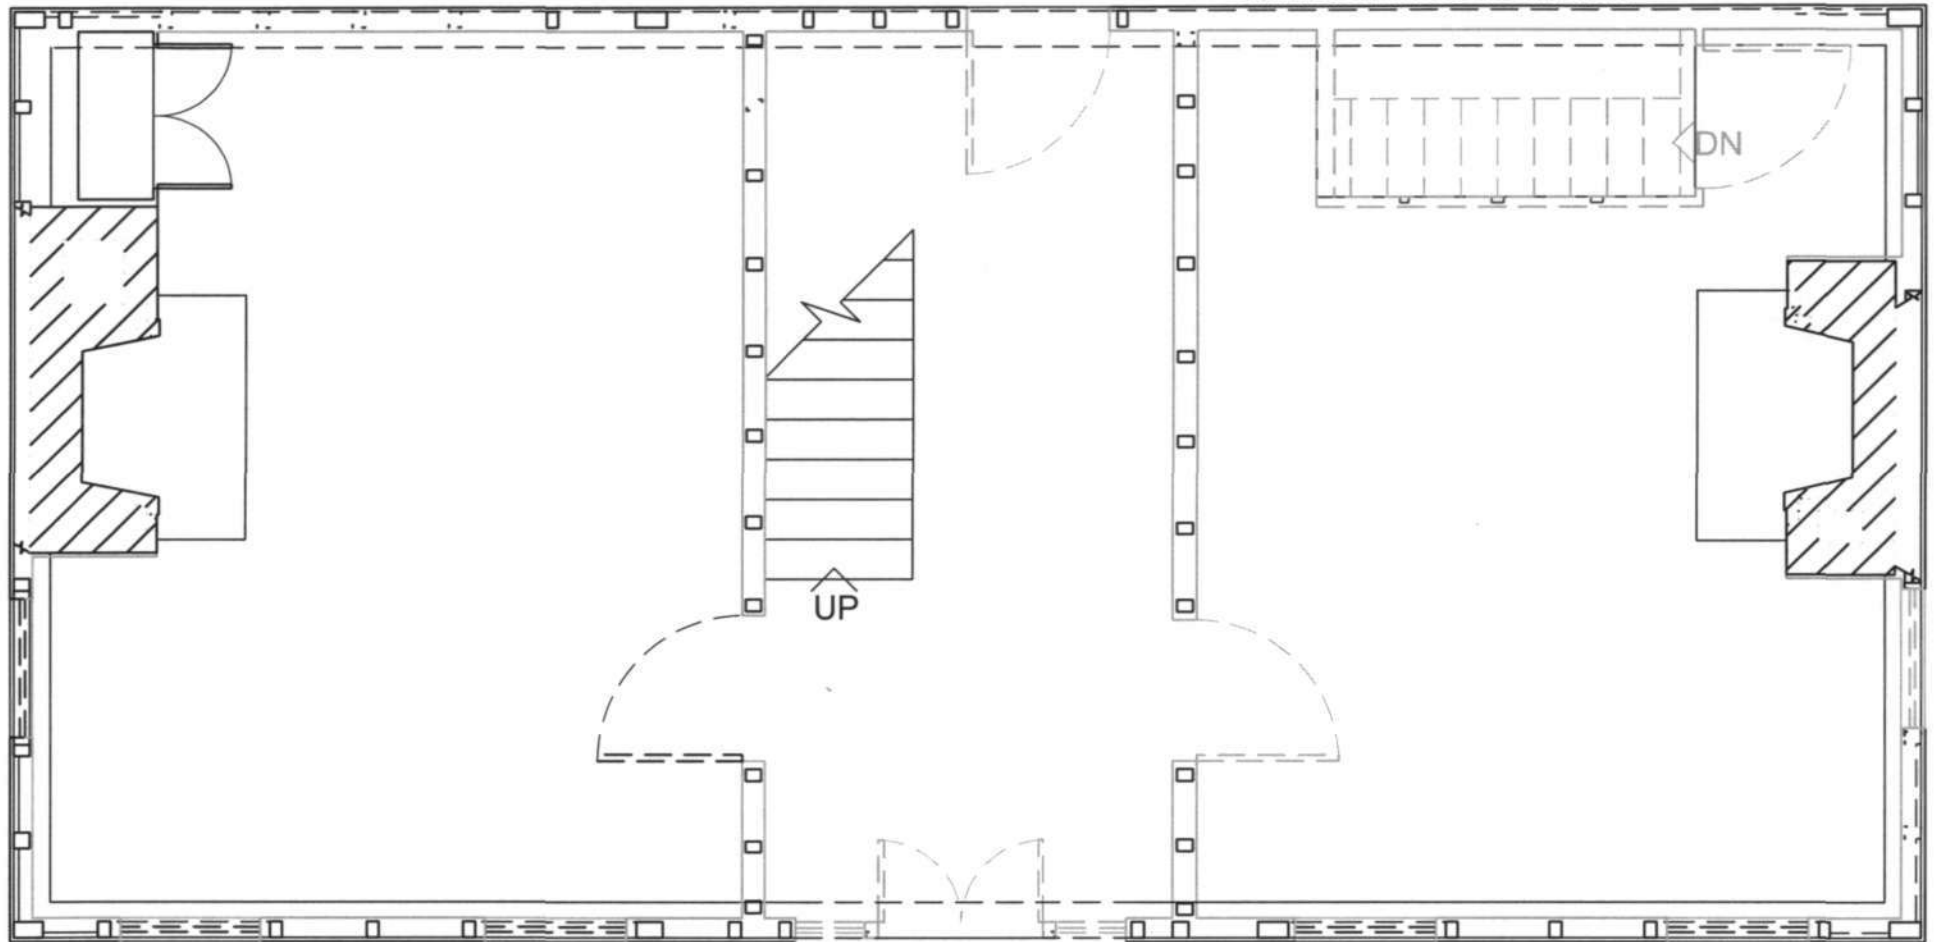
HO-98 McLAUGHLIN-CAMPBELL-LAUMAN BUILDING 8060 MAIN STREET, ELLICOTT CITY
FRAMING PLAN WITH RECONSTRUCTED FIRST FLOOR PLAN -- MEASURED AND DRAWN BY KEN SHORT -- JUNE 2009

The frame is made from hewn timbers, many of which were then sawn to size, with two-story corner and intermediate posts connected with girts that are mortised and tenoned and pinned. This seems to be a traditional heavy timber frame, but there are many transitional features, some of which are surprising to see as early as 1831. The posts are only 4 inches deep, not surprisingly, in order to be hidden within the walls, but are all braced with skimpy 1 by 8s that are nailed to the posts with mature cut nails. No double struck nails were found in the building, suggesting a construction date after 1820. Exterior wall studs are mortised and tenoned between the sills and girts, or between the girts and plates, but are not pegged; some of them may be nailed. The stair headers in the second-story and attic floors are not mortised and tenoned, but simply butted and spiked. Simplified building practices such as this have not been observed in other frame buildings in Howard County this early, and it is possible that new techniques being used in Baltimore were brought to Ellicott City by McLaughlin and his architect for Angelo Cottage, Alfred S. Waugh. It is not known whether Waugh had anything to do with the construction of the house on Main Street, but McLaughlin was busy building an addition to the Patapsco Hotel, so he may have been hired for this and all of the work going on.⁵

SILL, GIRT, & STUDS REPLACED. ORIGINAL FRAMING
CONFIGURATION NOT DETERMINABLE.

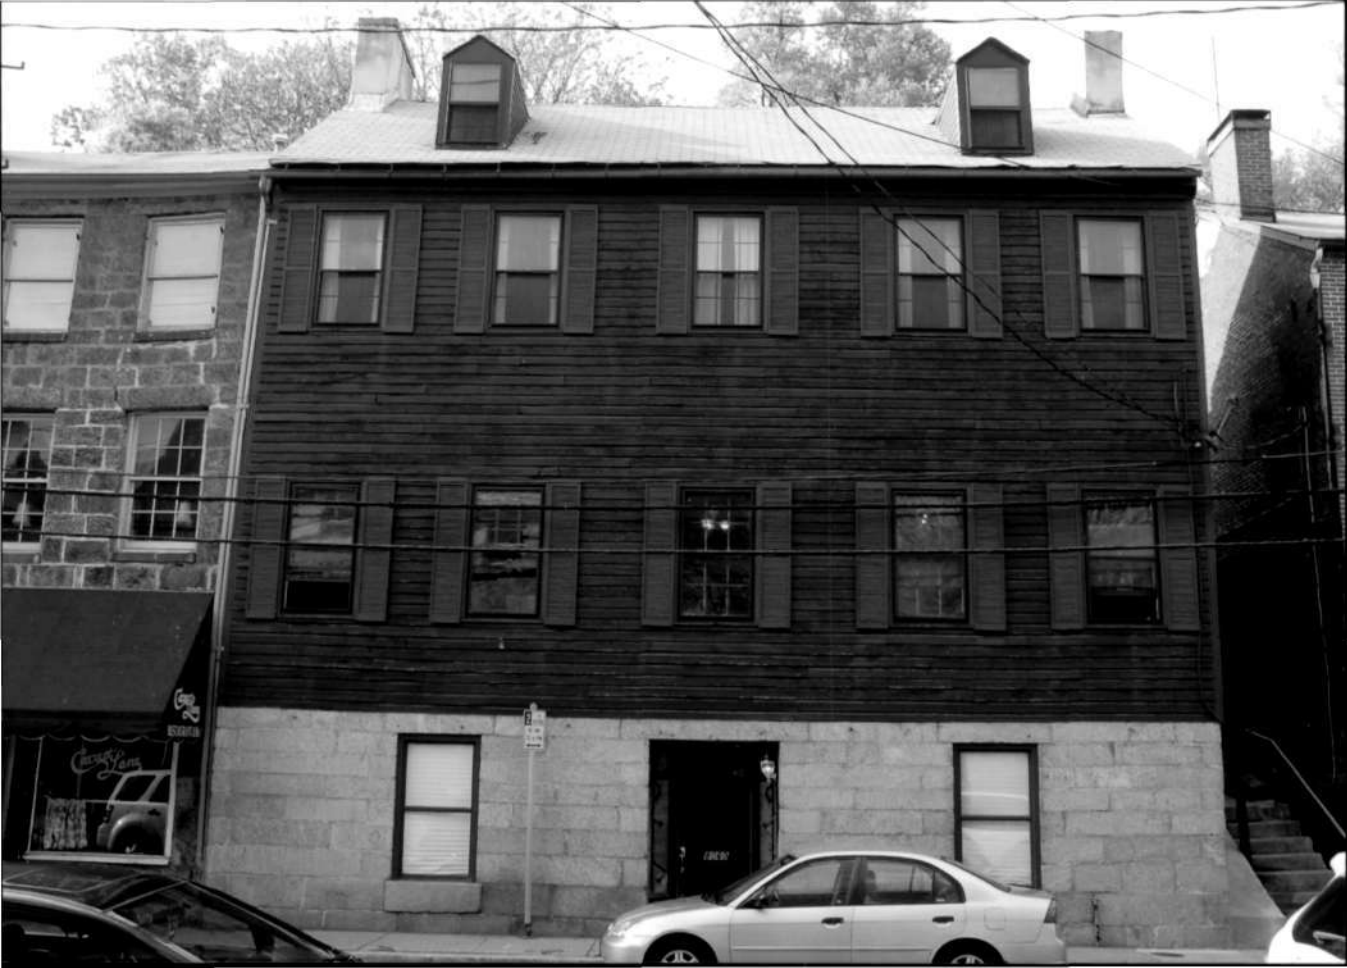
1 of 10

This is a two-story structure with an exposed basement on the south, and is five bays by two bays. The basement is granite ashlar on the south elevation and rubble stone on the other elevations, and the building has German siding on framing and a gable roof with an east-west ridge and asphalt shingles. The German siding has corner boards that have two rabbets. There are interior parged chimneys on the east and west elevations. The south elevation has a new center door in an original opening in the basement, with a one-over-one double-hung sash to each side. The window openings have granite sills and lintels and are original. The first and second stories each have five six-over-six sash with blinds. There are two dormers on the roof, between the end bays and the bays next to them, and they are gabled, have German siding on the cheek walls, and they have six-over-six sash. On the east elevation, the first story has a door set to the south and no opening to the north. There is a two-story shed-roofed addition attached to the north elevation, and the east elevation of this addition has a door on the first story. The second story of the main block has a six-over-six sash in the south bay and no opening in the north bay. The gable end has a four-light sash to the south of the chimney. The west wall is completely blocked by the stone building now known as Cocoa Lane Restaurant. The north wall is completely blocked by later additions that are not historic. The north addition was constructed in two stages, with the west half being earlier and having wire nails in the ledger boards. This was probably done when the German siding was put on the building. The east half of the addition has a CMU foundation wall and wafer board, and was probably done when the renovations were made in the 1970s.

South elevation

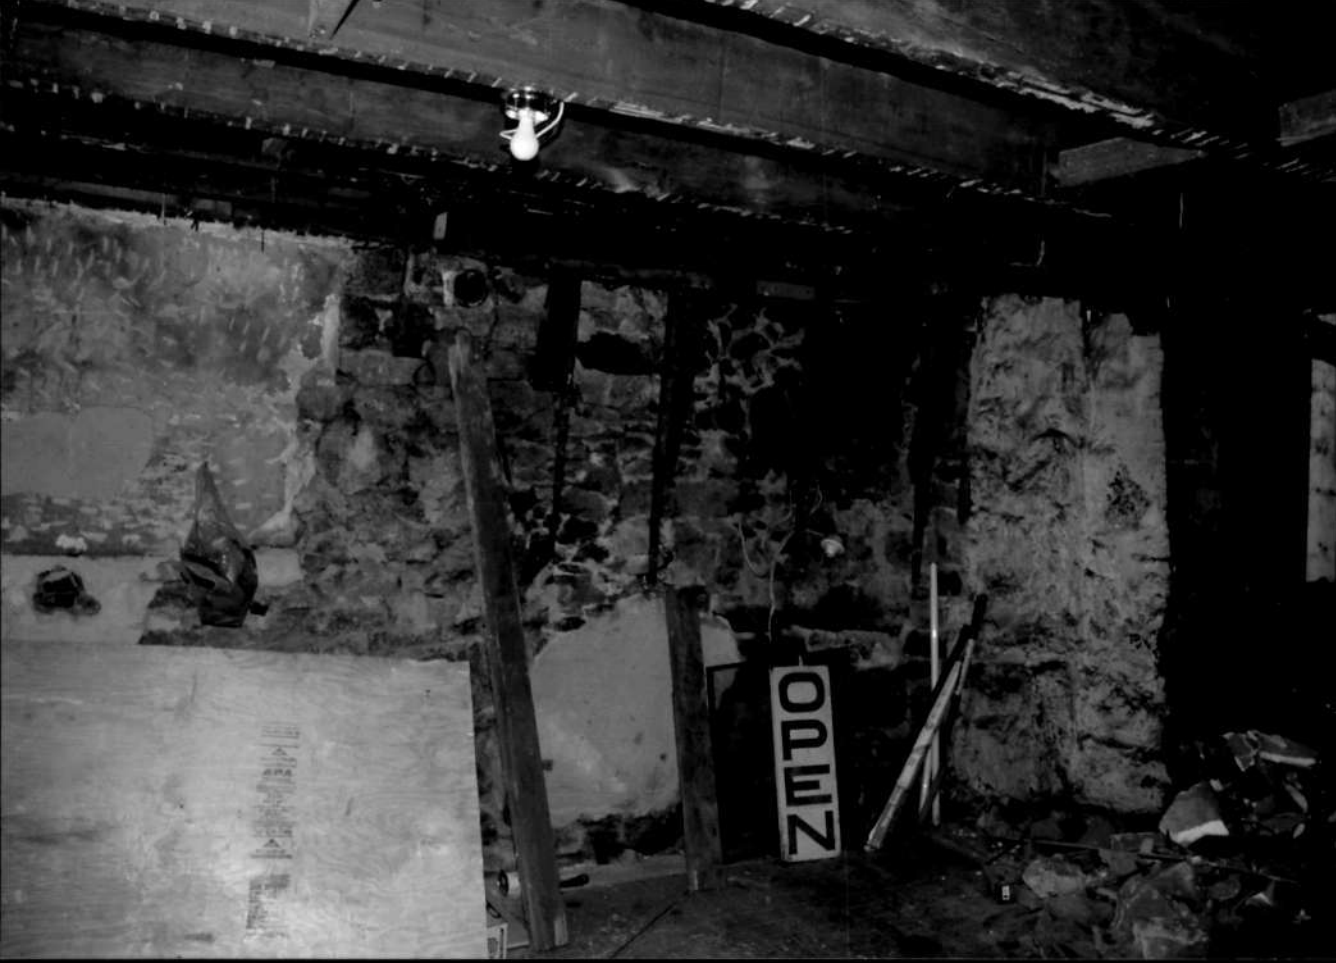
2 of 10

The west wall has no projection for the chimney, but has a stovepipe thimble in the wall just below the joists. The west joist is in two pieces and laps just south of center. The north half of this joist is set to the east and supported on wood brackets that are set diagonally, with their bottom ends set into the stone foundation wall. These diagonal brackets must have been added when a fireplace was taken out in the northwest corner. The west joist supports some corbelled stones just below the original west joist, that could not have been removed when the rest of the fireplace was pulled down. There may be a patch in the north jamb where the original manteltree was. These stones have heavy soot, as does the wall below them. There is a flue at the south end of the corbelled stones, and this flue is at the north end of the hearth of the fireplace above. The boards supporting the hearth above rest on a ledger board fastened to the joist. There is little evidence of the original fireplace in the northwest corner, but the north jamb of the fireplace survives against the north wall. It is not possible to determine how wide it was. The north wall, near this jamb at the west corner, has an original doorway to the exterior, with several brick steps up. There are wood nailers in the south and west walls that are added later and are large.

Opening up the basement has revealed that there were fireplaces in both rooms. The west room was probably the kitchen, and the fireplace was set to the north on the west wall. This room had an exterior doorway to the rear of the lot. Since the house is built on the side of a steep hill, the front of the basement is completely exposed, while the rear is below grade, and there must have been a stairwell leading up to the back of the lot and outbuildings there. The east room also had a fireplace that once had a mantel, and could have been an office, since there was access from the street, or an informal family dining room. This room was not as deep as the kitchen, because the stairway to the first story took up the northern portion of the room. This stairway probably ascended to the east, making a straight shot from the kitchen to the stairs. The east room above must have functioned as the formal dining room, then, even though the surviving cupboard is in the west room.

Basement, west elevation, with
remains of kitchen fireplace

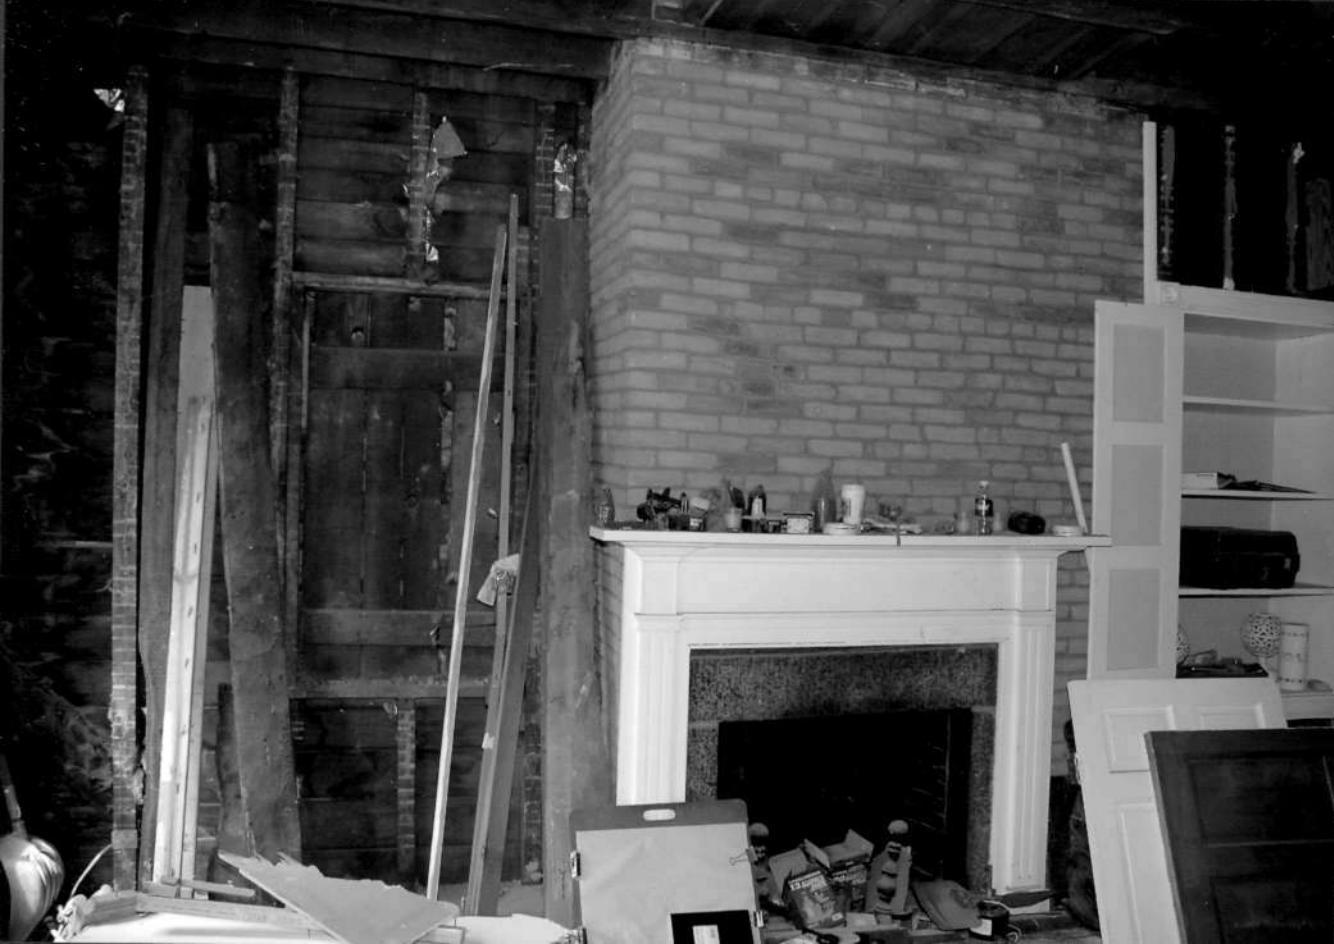
3 of 10

The west room has pine flooring, most of which is 5 1/2 inches wide but some of it is six or seven inches wide, and it runs east-west. The flooring is tongue-and-grooved and is face-nailed with T-heads. There is a fireplace centered on the west wall and the brick walls are now exposed, and appear to be new brick. The fireplace has a brick hearth, splayed brick jambs, and a firebrick floor and back wall of the firebox. There are granite facings that have a 4 3/4-inch face, are 5 1/2 inches deep, and are cut with a splay. The granite lintel is 9 1/4 inches high and 6 inches deep. There is a wood mantel that has pilasters, with two rabbets in each, and it has a plain frieze and plain impost blocks. The bed mould has a cavetto and bead below five small fillets, with a quirked Greek ovolo at the top. The mantelshelf is plain. There is a built-in cupboard to the north of the fireplace, and the architrave matches that of the door, with two rabbets. The corner blocks are better quality construction than on the door from the passage to this room, having deeper cuts to them. The cupboard has two one-panel doors below two three-panel doors, with the panels having sunken fields and no panel moulds. The doors are hung on case iron butt hinges with three knuckles, and the hinges are marked "22 x." There are three shelves in the upper half. Centered on the north wall is a 20th-century stairway that leads up to the rear addition. To the west of this stairway the wall has been opened up. The studs are sash-sawn, are 2 1/2 by 4 inches, and are

West room, west elevation

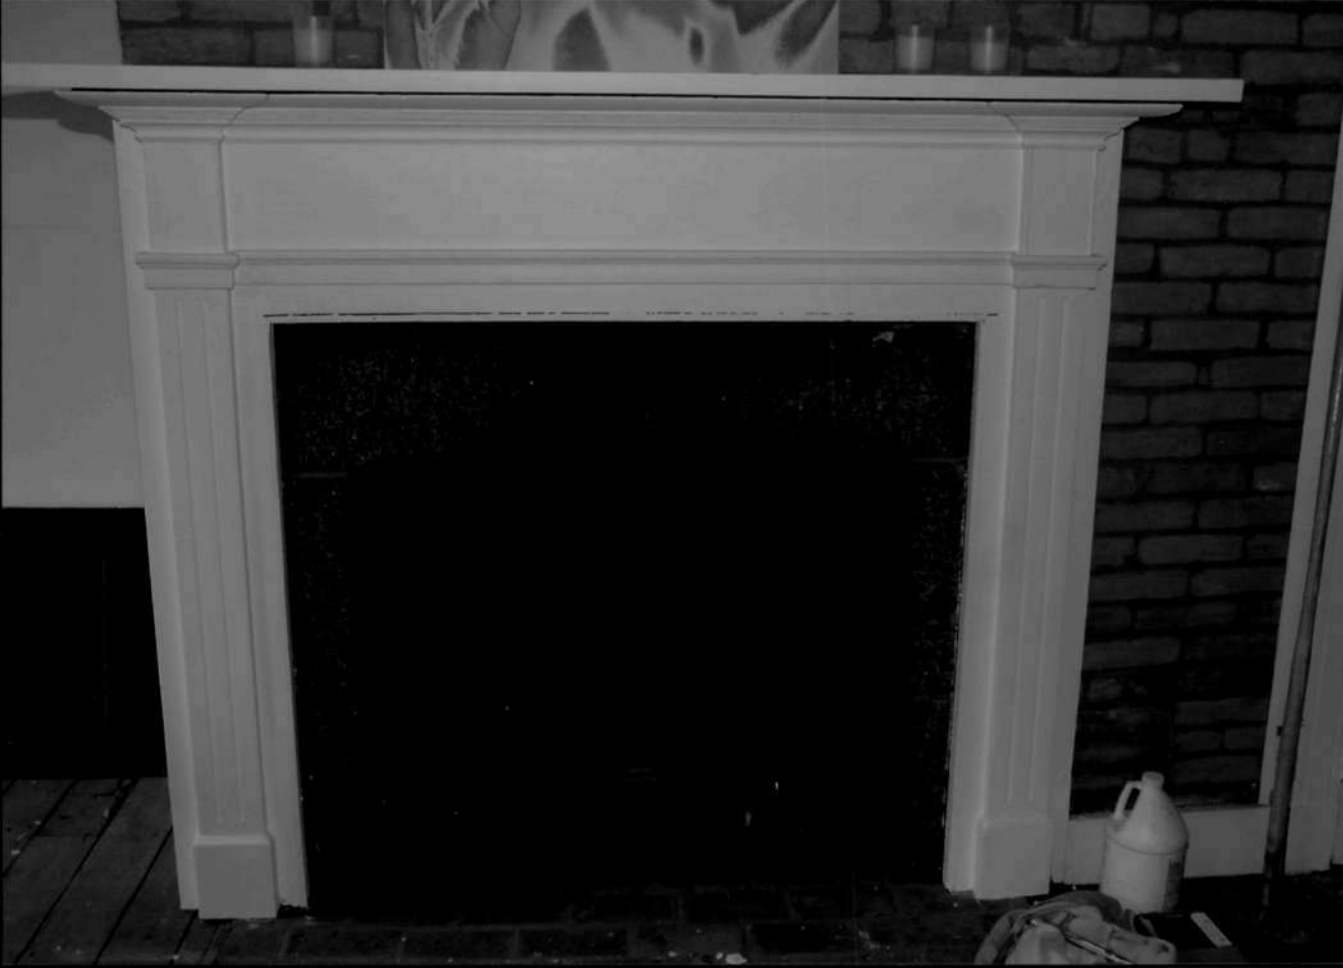
West room, west elevation mantel
4 of 10

The west room north wall west end corner post is 7 1/4 inches by 4 1/2 inches and is sash-sawn. In the first story west room, the southwest corner post is 7 1/4 inches by 4 inches, and has a nailer added to the side of it on which to nail plaster lath. The corner post has board down braces that are let into the exterior face, and the ends are staggered. The south brace is 1 1/2 by 8 inches and is 4 feet, 2 inches high, while the west brace is 1 1/4 by 8 1/4 inches and is about 3 feet, 4 inches high measured from the floor straight to the top of the brace. The posts are two stories tall with the girts mortised, tenoned and pinned between them. The north girt is 4 inches deep by 5 1/2 to 6 inches high. The studs have a center tenon into the girt, and they may be nailed. The northwest corner post has a board downbrace on the interior. There is a center post in both the north wall and the south wall, near the east partition wall. This post on the north wall has a down brace from the top, where the girt joins it, to the west, on the interior face.
